Final Report of Fishery Resource Grant Project 2017

Project Title: Determine Methods to reduce Bycatch of juvenile Atlantic croaker (*Micropogonias undulatus*) in Haul Seines (Continued)

Name of PI: George Earl Trice V

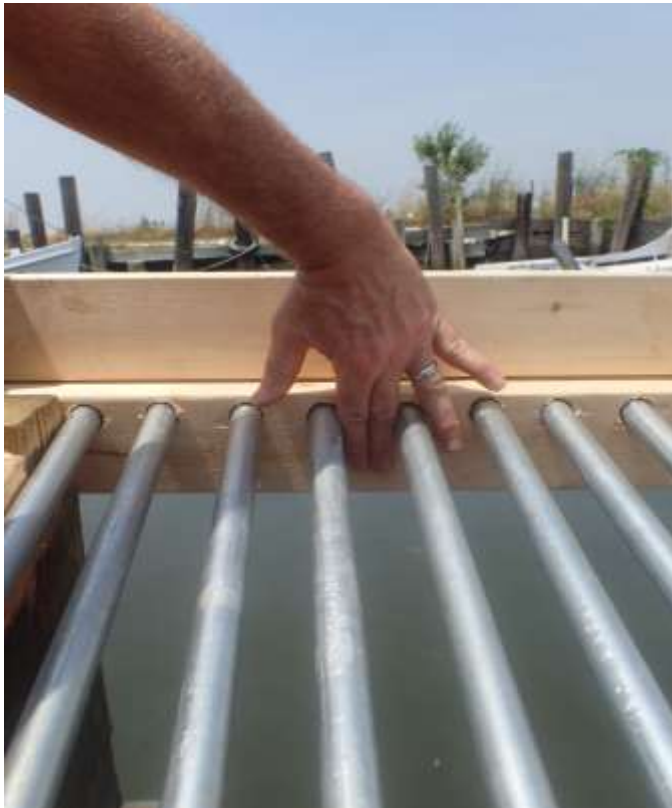
Figure 1. Cull table used showing initial spacing of metal pipes (grating) designed to allow small fish to pass through.

A wooden culling table measuring 4'x4' using 18 one-inch diameter galvanized pipe (Figure 1), was used to separate fish by size during the brailing stage (transferring fish from seine pocket to boat deck using a 200 lb. capacity brailing net (Figure 2). The purpose of this culling table was to reduce the amount of small "baitfish harvested. The initial Intention of the study was to start with the table in a position that released the small fish that fell through the pipes (grate) of the table into a chute that would move fish over-board (Figure 3,4). However, in order to obtain information on the size of fish being culled, and what necessary adjustments to the table may be needed to maximize its effectiveness, the chute was not used and all fish brailed onboard were kept. The boat deck, were fish are landed on-board, was partitioned in half using 2x12 lumber with fish culled out from table (small fish) channeled to one side and the fish not culled (larger fish) channeled to the other side. In this study, fish that did not fall through the grating (pipes) are termed "Un-Culled fish". Fish that fell through the grating are

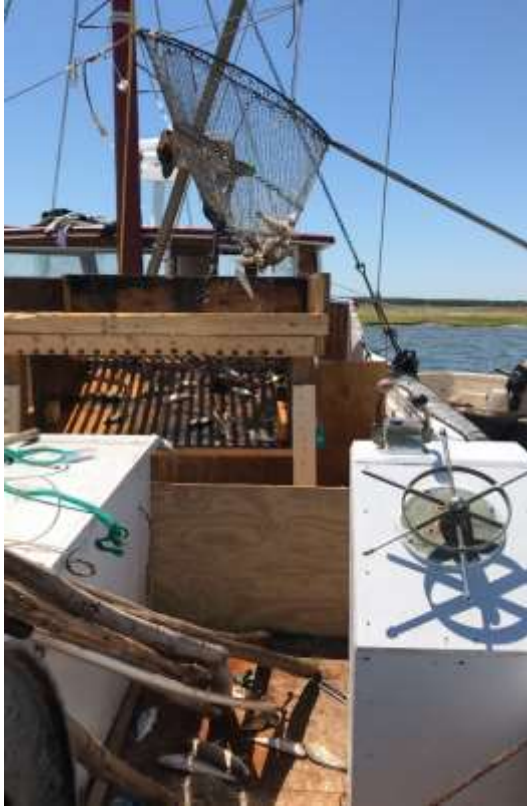
Figure 2. Fish brailled from seine pocket onto culling table on boat deck.

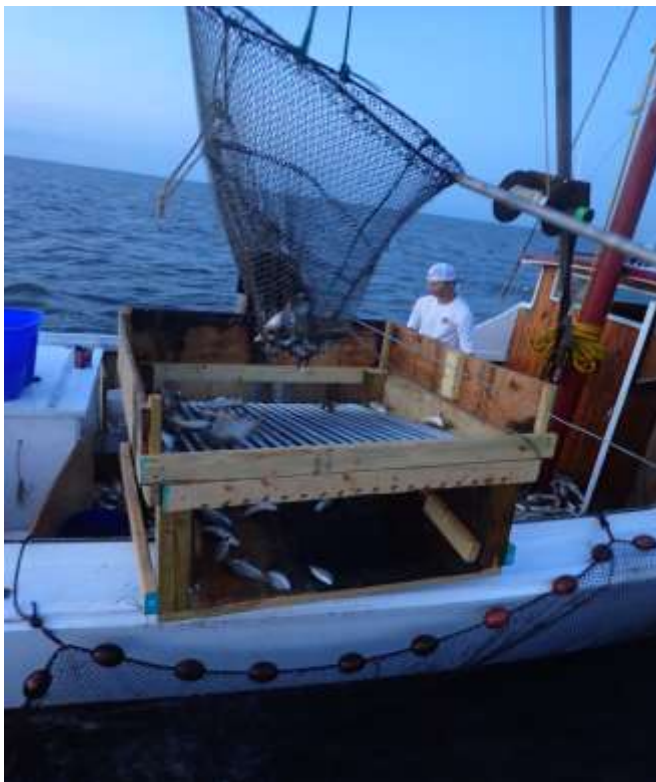
Figure 3. Fish culling table actively separating fish by size. The spacing and slope of pipes were adjusted to improve culling.

During the study, changes were made to the culling table to increase its effectiveness. Changes that were made to the culling table included changing pipe spacing, slope (gradient) of the pipes which make up the grate, height of the culling table walls (fish piling up on table were spilling over the table), and bracing of the pipes to minimize pipe bending when a load of fish were placed on table. Initially, the grate part of the cull table consisted of pipe spacing of 1.5” (pipe-to-pipe) with a slope of 2.5/12 (0.21). The initial slope of the chute that moved fish overboard was 2/12 (0.17).

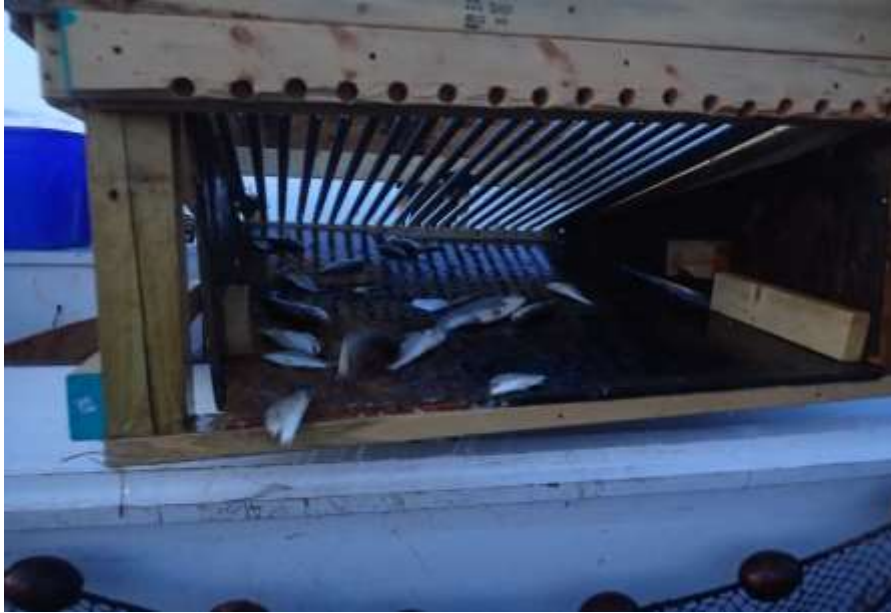
Figure 4. Fish culling table separating small fish from catch and channeled back into the water alive.

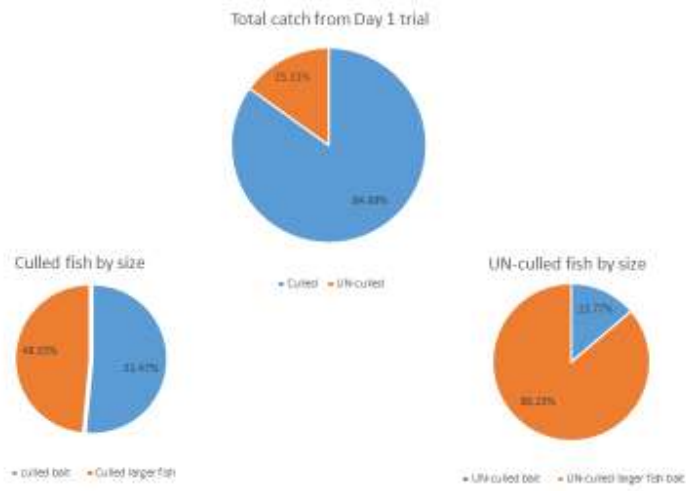
Figure 6. Day 1 fishing trial results (N=2403). Cull table pipe spacing of 1.5".

During the first fishing trial (Day 1) it was obvious that the pipe spacing was too far apart with fish considerably larger than baitfish size culled in large numbers (Figure 6). Of the total catch, the majority of fish landed (84.9%) were culled through the table, with over half of the Culled fish larger than the bait-size fish targeted by culling table. As a result, the spacing of the pipes from each other was reduced from 1.5" to 1.25" and tested in fishing trial Day 2.

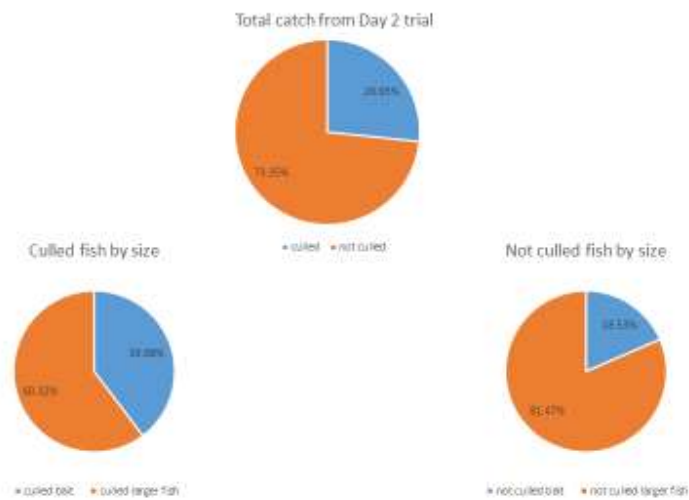
Figure 7. Day 2 fishing trial results. Culling table pipe spacing was decreased from 1.5" to 1.25".

In fishing trial Day 2, reducing the pipe spacing reduced the amount of larger fish culled out. During fishing, the decreasing of pipe spacing to 1.25" appeared to retain more of the smaller targeted fish while continuing to cull out the smallest baitfish. However, upon grading catch at the dock, a larger portion of Culled fish (60.32%) were fish larger than bait (Figure 7). The amount of UN-culled baitfish remained similar to that in trial Day 1. The walls for the culling table were found to be too short (10'), resulting in fish of all sizes spilling off the top of the table when fish were loaded onto the table. These fish spilled over onto the boat deck resulting in culled and un-culled fish mixing. This mixing resulted in inaccurate grading of culled and UN-culled groups. This situation resulted in the walls of the culling table raised in height to 16" to minimize fish spillage from the table during culling.

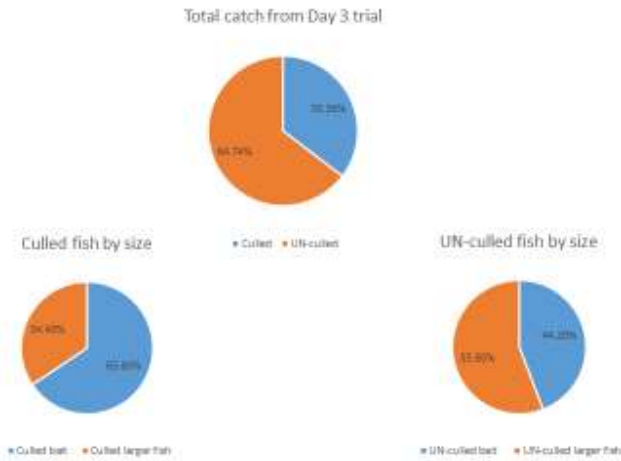
Figure 8. Day 3 fishing trial results (4538 lbs. landed). Fewer larger fish culled by table than in previous trials.

Results of fishing trial Day 3 showed that pipe spacing at 1.25" continued to cull out target bait-size croakers as well as the next size up fish, but not as many larger fish (34.4%) from previous trials (Figure 8). It was observed that resident time of fish on the grated table (pipes) was not long enough to allow for maximum culling of small fish before moving off table into Un-culled pile. The fish appeared to be moving too fast over the table, suggesting that the grate (pipes) had too much of a slope (2.5/12), not allowing fish time to fall through the pipes. The slope of the grate was reduced to 1/8 (0.13) for the next trial.

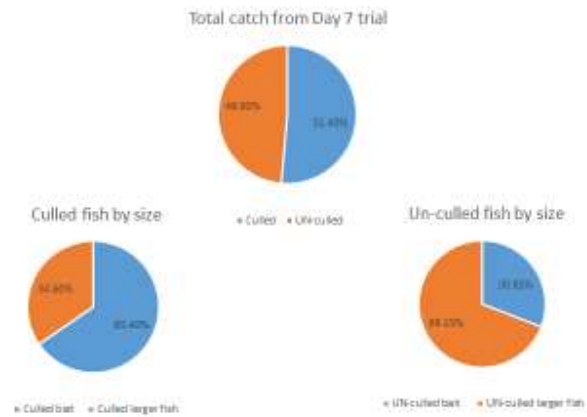
Figure 9. Day 7 fishing trial (1934 lbs. landed).

Trial Day 7 was the first time the majority of fish landed were culled fish (51.40%), with less baitfish present in the Un-culled fish (Figure 9) compared to the last trial in which a good number of fish were landed (Figure 7). Reducing the pipe spacing to 1" seemed more effective in culling out the smaller fish while retaining larger fish. However, there remains a significant amount of baitfish (30.85%) within the Un-culled fish. The pipe spacing was further reduced to 0.875" for the next trial.

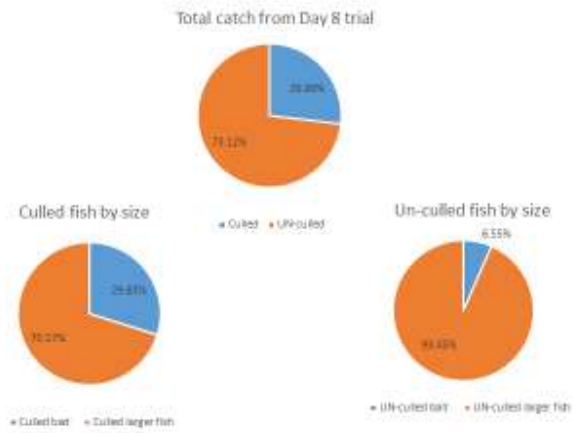
Figure 10. Day 8 fishing trial (8107 lbs. landed).

The largest amount of fish landed for this project was in trial Day 8 with 8,107 lbs. of fish weighed and graded (Figure 10). With the grate slope held at 2/12 and the pipe spacing reduced to 0.875", there was a significant reduction of fish culled as bait over trial Day 7. In Un-culled fish, the fewest amount of baitfish was observed over all trials, suggesting successful culling of baitfish, however, a large proportion of these larger fish were small (2,729 lbs.) croakers border lining baitfish size. In Culled larger fish, a large proportion of these were small, but not bait size croakers (40.8%), suggesting that finer culling can possibly be obtained. The pipe spacing was further reduced to 0.815" for testing in the next trial.

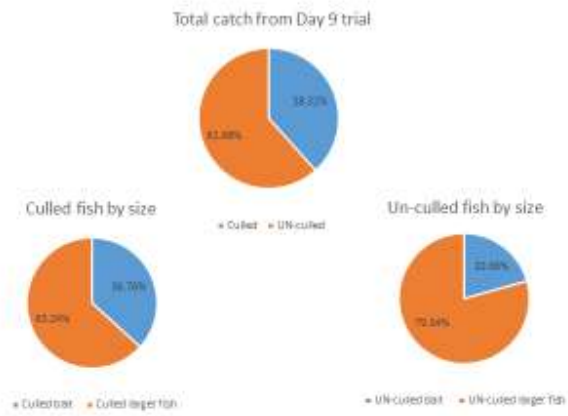
Figure 11. Day 9 fishing trial (1177 lbs. landed).

In trial Day 9 about a third of the catch was Culled to baitfish (Figure 11), more than that observed in previous trial with wider pipe spacing. Reducing the pipe spacing from 0.875 to 0.8125 seemed to reduce the amount of larger fish in Culled fish, but increased the amount of baitfish in Un-culled fish. A slight flexing of the pipes towards the center of the grate was observed when a load of fish were brailed onto the table. This flexing likely results in larger and inconsistent spacing between pipes during culling. For further trials, a metal bar was placed under the pipes in the middle of the grate table to support the pipes and reduce flexing.
