4 Captain Sinclair

(Excerpt from “[Living Shoreline Sea Level Resiliency: Performance and Adaptive Management of Existing Sites](#)” report)

4.1 Site Background

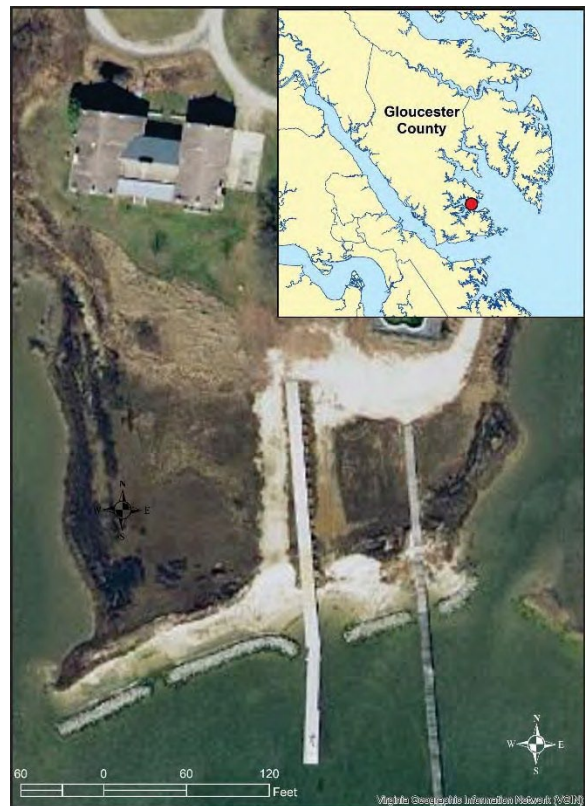
Figure 4-1-1. Location of the living shoreline at Captain Sinclair's Recreational Area.

Captain Sinclair Landing Recreational Area (CSRA) is located near the mouth of the Severn River in Gloucester County, VA (Figure 4-1-1). In 2013, almost 100 acres of property was gifted to the Middle Peninsula Chesapeake Bay Public Access Authority (MPCBPAA). The Middle Peninsula Planning District Commission (MPPDC) partnered to the Public Access Authority to develop a management framework for the property. The MPPDC also partnered with the Shoreline Studies Program at VIMS and received a NFWF Small Watershed grant in order to accomplish the Shoreline Management Plan for the property as well develop a living shoreline demonstration site and educational outreach program.

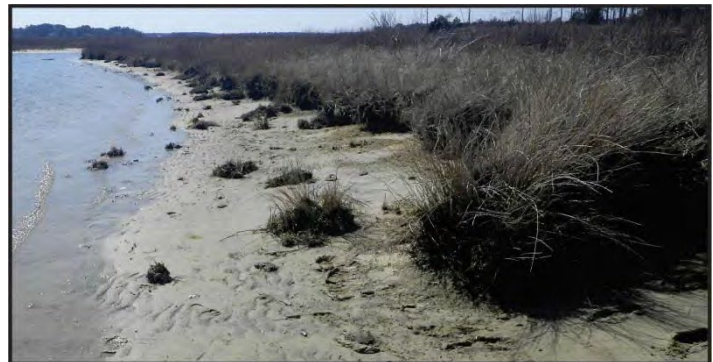
Figure 4-1-2. Conditions at Captain Sinclair before the project. Photo: Shoreline Studies Program, 1 April 2015.

CSRA is set within the low lying landscape that surrounds the Mobjack Bay. The tidal shoreline is eroding marsh dominated by *Spartina patens* and black needle rush (Figure 4-1-2). Significant shore recession has occurred in front of the main house which has erosion rates of about 0.6 ft/yr. The tide range is 2.5 feet at the mouth of the Severn River. The project was designed to address shoreline erosion along the project coast. There is a fetch to the west of about 2.5 miles and the southwest of 1.8 miles, low medium energy exposure. The upper elevation of sand fill was set at +3.0 ft MLW and extends on a 10:1 slope to about mean tide level at the back of the proposed stone sills. Once established the project will provide an erosion-control marsh fringe. A new pier recently was built along the shoreline.

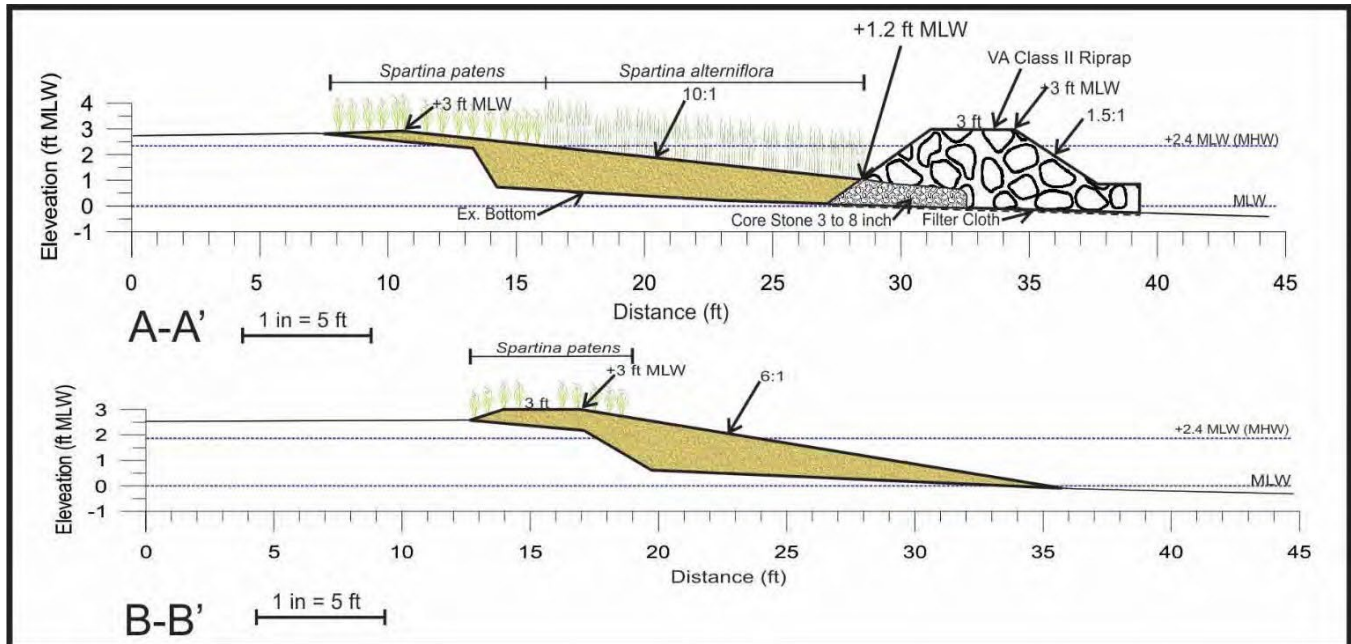
Figure 4-1-4. Typical cross-sections for the Captain Sinclair living shoreline project by Shoreline Studies Program, VIMS.
