VIMS escapes major damage from Irene

(August 29, 2011) The Virginia Institute of Marine Science escaped any major damage from Hurricane Irene, with minor flooding of the VIMS Boat Basin the only noticeable effect of the storm.

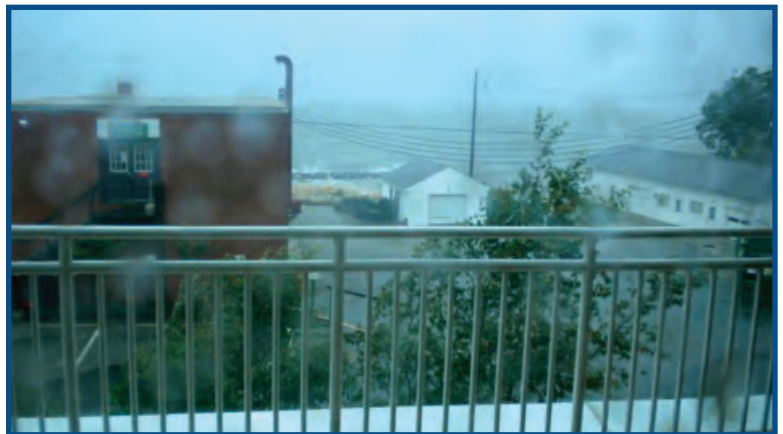
Waves hit the VIMS shoreline during Hurricane Irene. Photo from Andrews Hall at ~ 2 pm on Saturday August 27th by David Forrest.

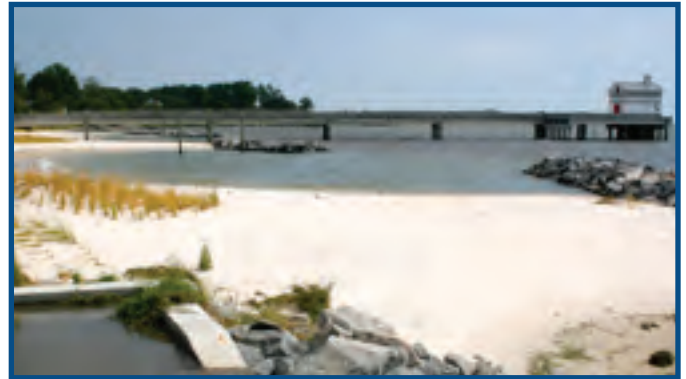
Also in the mix is the new VIMS shoreline. Completed in 2010, the shoreline was designed by Scott Hardaway of VIMS' Shoreline Studies Program to use stone breakwaters, sand, and native plants to protect the VIMS shoreline and campus from storm tides and waves.

New elevated concrete pier and stone breakwaters minimized damage to the VIMS shoreline during Hurricane Irene.
