# Leesylvania State Park Living Shoreline Project Monitoring Protocol

Shoreline Studies Program  
Virginia Institute of Marine Science  
William & Mary

May 2019

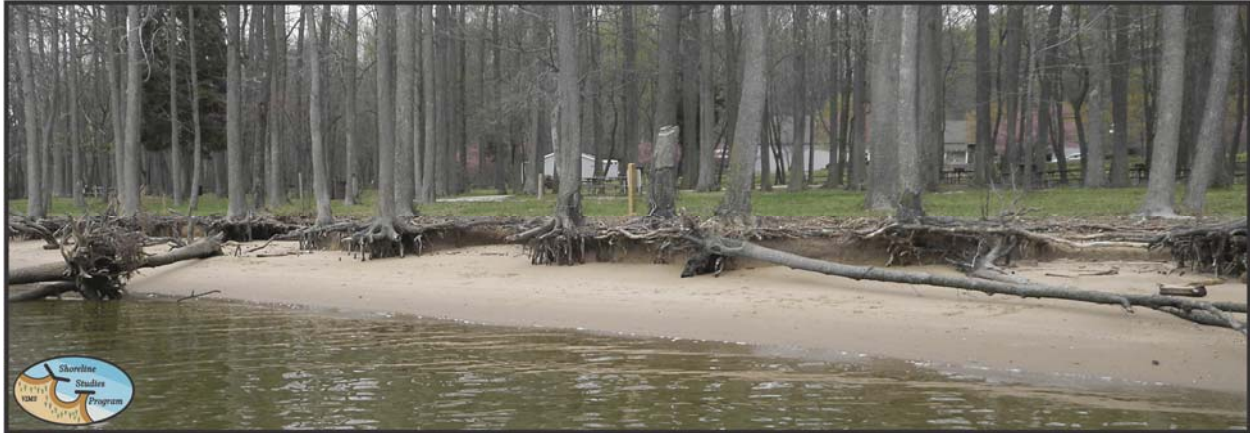
Figure 3. Pre-project eroding Potomac River shoreline at Leesylvania State Park. The scarped bank, exposed roots, and fallen trees made the shoreline unsafe for visitors. Photo taken by Shoreline Studies Program, 21 March 2012.

Leesylvania State Park is located along the Potomac River in Prince William County, Virginia (Figure 1). It is one of the most highly used state parks in Virginia with attendance topping 600,000 (Anne, 2017). The project shoreline occurs on the southeast-facing Potomac River shore north of the marina (Figure 2). This section of coast is very low and is exposed to long fetches across and down river. Prior to the project, the shoreline had a scarped bank, exposed tree roots, and falling trees which was unsafe for park visitors (Figure 3).

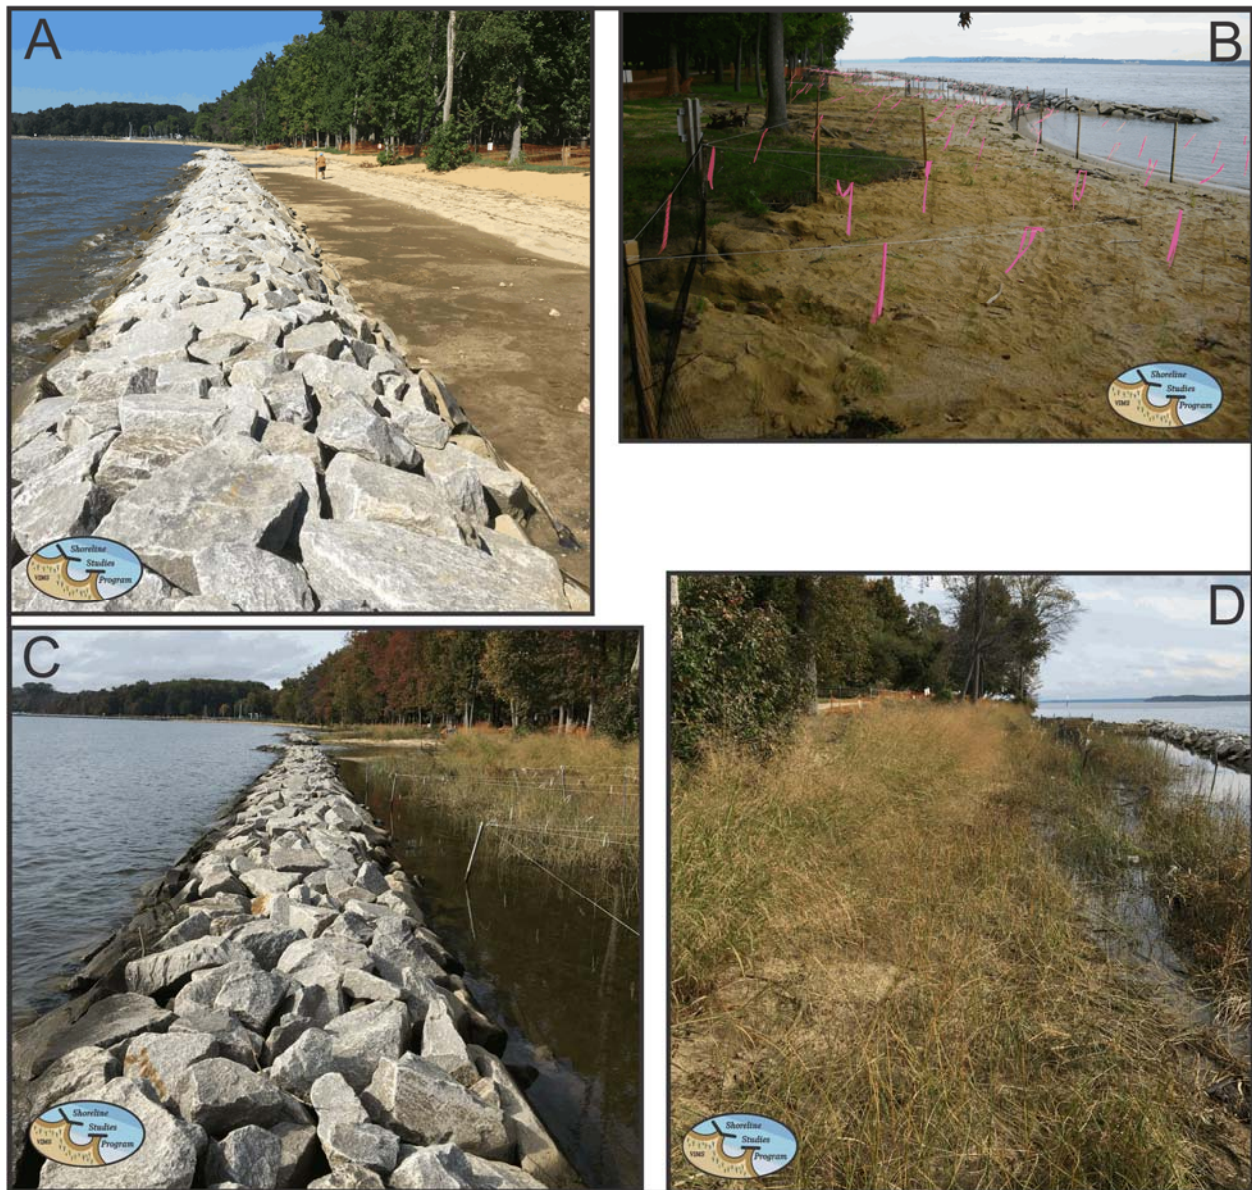
*Figure 5. A) Rock sill 1 and sand fill after installation but before marsh planting (12Aug2016); B) Marsh grass planting and goose fence installation (1Sep2016); C) Sill 1 approximately one year after installation (23Oct2017); and D) high marsh grasses behind sill 1 after about one year (23Oct2017). Photos by Shoreline Studies Program, VIMS.*

This project was funded, in part, through the Living Shorelines Initiative grant program, administered by the Chesapeake Bay Trust in conjunction with the National Oceanic and Atmospheric Administration (NOAA) Restoration Center and Maryland Department of the Environment. The first phase of the project was built in 2016 and included rocks sills 1, 2 and part of 3 along with sand fill (Figure 5A). The marsh grasses (*Schoenoplectus pungens* and *Panicum virgatum*) were planted, and exclusion fencing installed a month later (Figure 5B). A

year later, the marsh grasses were well established (Figure 5C & D). The rest of the designed Living Shoreline project, the remainder of sill 3 and sill 4 was installed in 2018 (Figure 6).

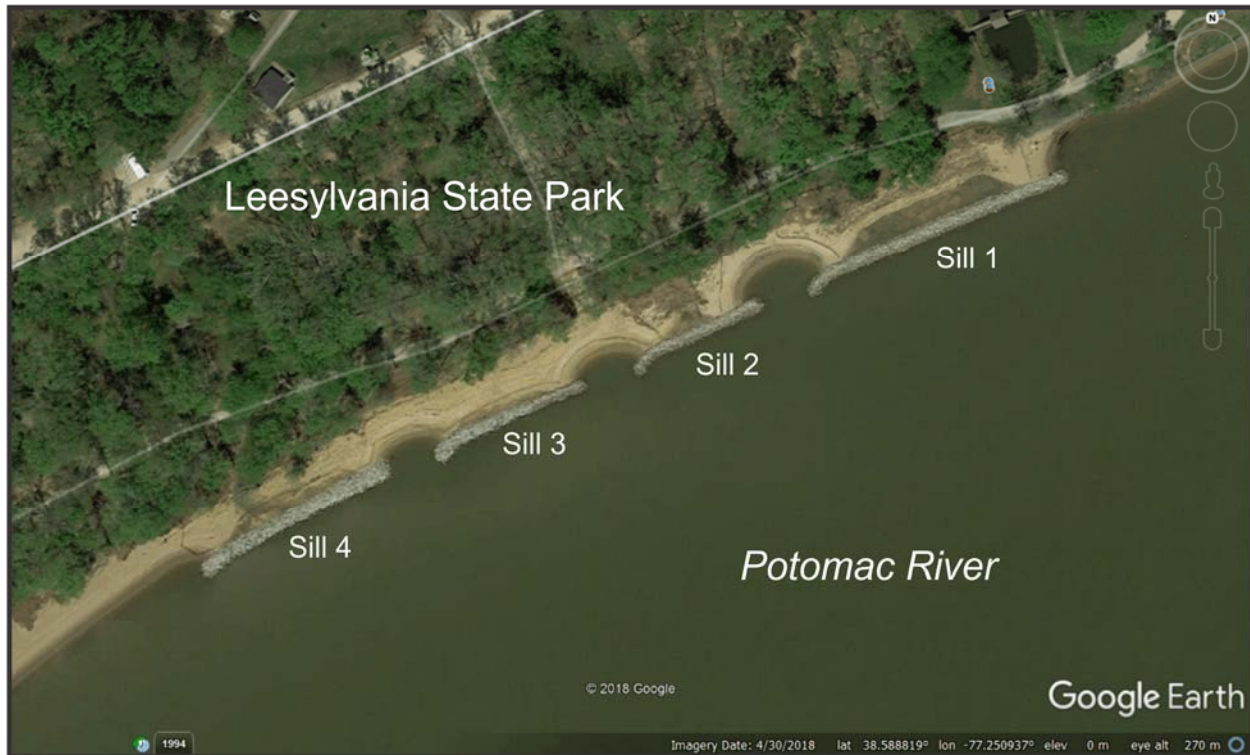
*Figure 6. Google Earth image showing the installation of all four sills as designed. As of the photo date, sills 1 and 2 had been in place for about 1.75 years. The remainder of sill 3 and sill 4 had just recently been installed.*

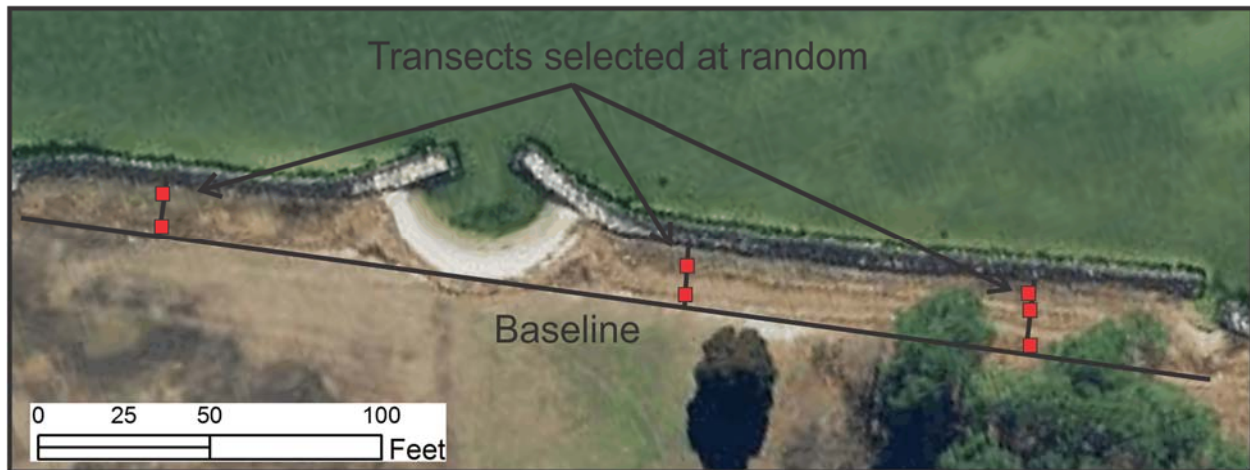
*Figure 7. Vegetation sampling schematic. The baseline occurs along the upland/marsh boundary. Transects are selected by random numbers table along the baseline. The plots are selected randomly from the baseline.*

During the first year of monitoring it is critical to identify areas of rapid sand loss and large areas of plant mortality if these should occur. These factors can indicate flaws in the design or implementation. The causes of these problems need to be identified so remedial actions can be implemented to ensure the long-term success of the project. For example, if there is an area of rapid sand loss, you need to ask: Are the sill gaps too wide? Is the sill too low? Is the sand the right grain size? In the case of excessive vegetation mortality, you need to ask: Have the plants been planted at the wrong elevation? Are the plants not suited for the salinity regime? Were the plants washed out by a storm event? Is there a herbivory problem from geese or muskrats? Remedial for actions for sand loss can include: adjustment to the sill design to increase sand retention or the addition of coarser sand. For vegetation loss remedial actions might include: planting different species of plants better suited to the existing elevations or salinity regime or providing goose exclusion fencing to eliminate herbivory problems.

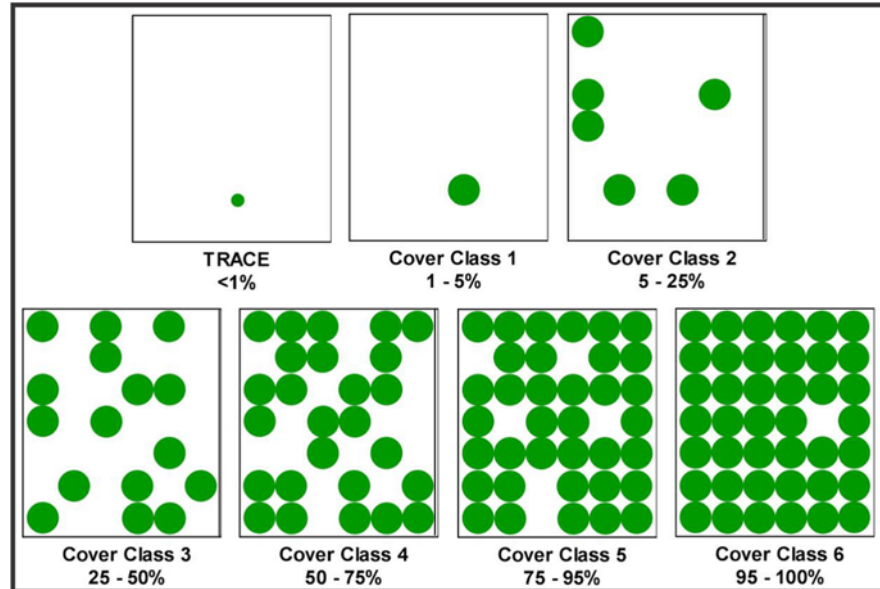
Figure 8. Percent cover depiction for vegetation monitoring. From Connecticut Sea Grant (n.d.).

These plots should be sampled in the late summer or early fall for percent cover, tallest stem length, and the number of flowering shoots. Percent cover (Figure 8) is usually defined as the vertical projection of the shoot area to the ground surface expressed as a percentage of the plot area (Mueller-Dombois & Ellenberg, 1974). Another way of expressing this is to assume a light bulb is hanging directly over the plot with the shade from the light on the ground being the percent cover. This should be determined for each species. The percent bare area, the area not shaded by vegetation, should be recorded as the percent no cover. Stem height and flowering shoots are measures of plant vigor that indicate the development of a viable plant population.

As an alternative to actual percent cover, cover classes can be used to simplify the process (Daubenmire, 1959). In this process, a range of percent cover is used to quantify the cover in each plot (Table 1 and Figure 8). This can facilitate the determination of cover and reduce the time and effort involved. The midpoint of each cover class can be used to calculate the average percent cover for the site. Vegetation is an important component of the overall shore protection system and must be thriving for the project to be a success. If plants are not thriving, shading should be considered as a cause. Growth of trees and shrubs over time can impact the amount of sunlight hitting the shore thereby reducing plant growth.
